APTNE
16

Annual Meeting and Symposium

**Water and Its Impact on
Historic Sites & Structures**

Water and Its Impact on Historic Sites and Structures

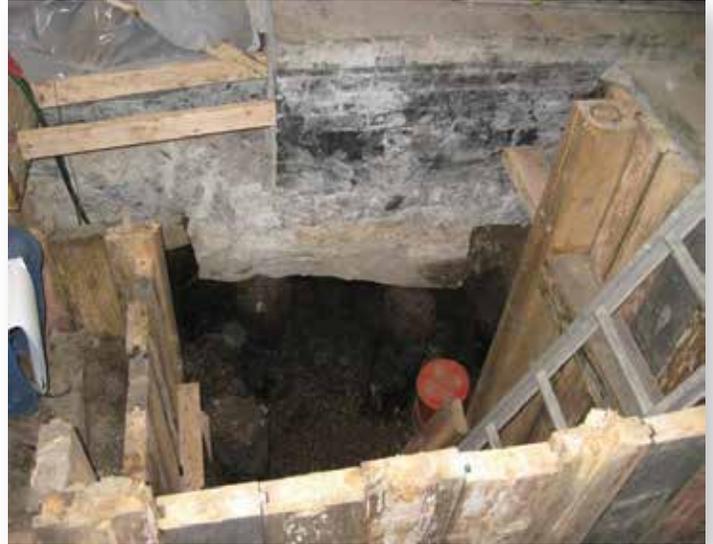
Several historical structures in the New England area are supported on timber piles extending through reclaimed fill and organics into the underlying marine soils. Due to lowered groundwater levels, as a result of underground construction, leaking utility lines, and leaking basements, several of these buildings have been affected by severe deterioration of the timber piles that support them. As groundwater levels decrease, the tops of the timber piles are exposed to air. Exposure to oxygen and high moisture conditions is conducive to growth of fungi and bacteria which can lead to decay of the tops of timber piles, loss of building support, and consequent settlement. As most historic buildings in the New England area are brick masonry structures, they are particularly sensitive to movement which can result in cracking of the structural framing and the interior and exterior finishes.

Groundwater recharge systems in combination with cut-and-post underpinning (to remove the deteriorated portions of the timber piles) are frequently used to mitigate lowering groundwater levels, possible future pile deterioration, and areas of already deteriorated piles. Given typical access constraints in historical structures, this process of underpinning and ground water recharge can be, and usually is, a significant investment. The planning and design of there charge system needs to be well thoughtout not only to maximize the efficiency of the system, but also to allow for the inclusion of safeguards and redundancies that will extend its service life. Post-construction monitoring of the recharge system's performance and the commitment of the Owner to its regular maintenance are key items for a successful implementation of this remediation option. →

Our presentation will discuss how timber pile deterioration develops, how buildings are impacted by the consequent displacement, and how a carefully planned and well-designed recharge system can help reduce the potential for pile deterioration. We will identify the key components for design of their charge system, its installation, monitoring, and maintenance.

We will also present a case study of a historical building in downtown Boston where differential settlement due to timber pile deterioration required the design and implementation of a remediation program which included underpinning of the most risk-critical parts of the structure, as well as the design and installation of a charge system to increase groundwater levels above the tops of the timber piles. The recharge system is regularly monitored to allow timely identification of any issues that may arise during its service life such as, for example, a drop in recharged groundwater levels due to clogging of the drainage pipes. ●

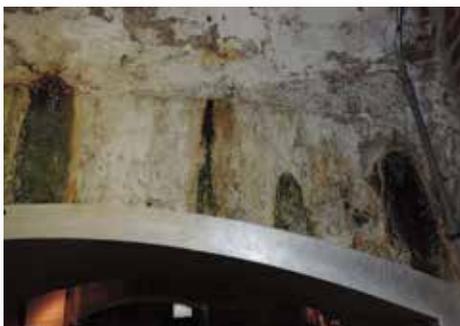
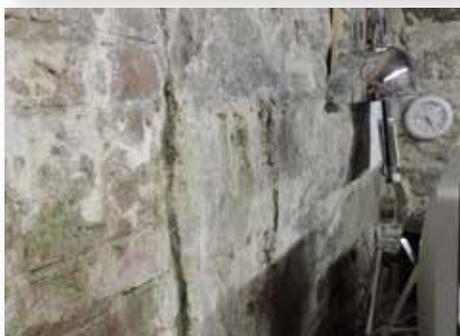
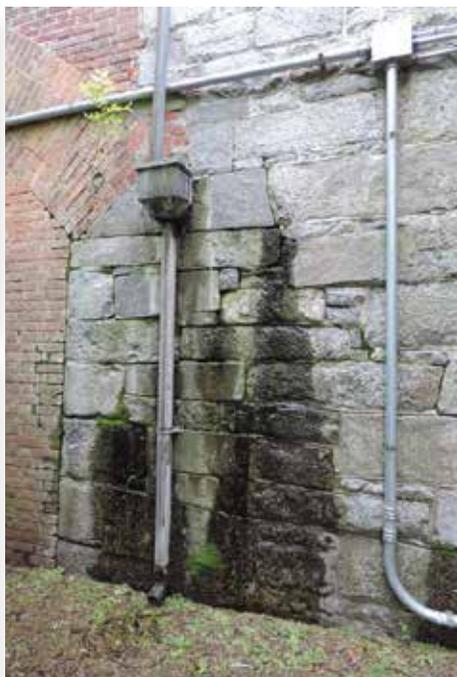
Specifically the speaker will describe the construction of the masonry walls, vaulted casemates, and the earthen ramparts; noting that the scarp and perpendicular casemate walls were not structurally connected. This was an intentional design technique that allowed the walls to move separately, but created the potential for a larger separation between the adjacent walls. This portion of the presentation will also describe the casemate roofs and drainage system that theoretically conducted water from the ramparts and terreplein to the ground level and cisterns. This portion will conclude with the first reports from the US Army Corps of Engineers of water infiltration in the casemates. →

The second portion of the presentation will elaborate on some of the inherent design issues that contribute to the water infiltration problems. Those include the earthen overburden, the open joints between the scarp and casemate walls, incompatible geometry at the angles of the bastions, and penetrations that allow water to migrate from the exterior of the fortification to the interior of the casemates. This portion will also describe some of the later alterations that may have exacerbated the water infiltration problems. The speaker will discuss some of the previous attempts to solve the water problems at Fort Monroe that range from the construction of relieving arches in the 19th century to alterations to the drainage systems, addition of bituminous materials on the terreplein, and installation of drip pans in the 20th century.

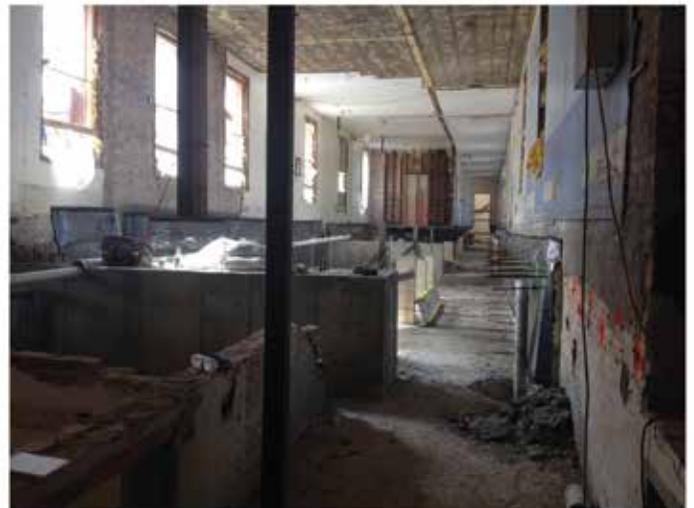
Floodproofing Detail: Historic Core
Option A (Schematic Design Option)

3. Thou shalt balance new technologies with historic fabric: Two flood proofing methods were considered for the project—dry and wet. Dry flood proofing involved more significant changes to the historic structures and is a more expensive method but provides a higher degree of protection. The decision to wet flood proof was used at the most historic and elevated locations.

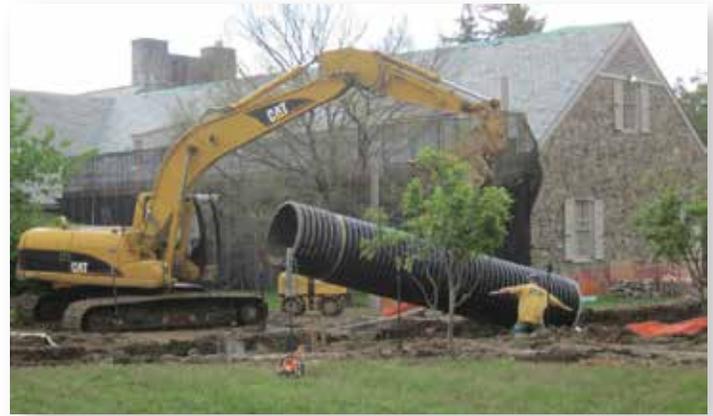
The flat, clayey site, the historic view-scape, and NPS ownership of surrounding land demanded an unusual approach to managing a 100-year storm. A retention pond was proscribed; existing drainage was a single 6" pipe exiting on a river bank. A bracelet of huge site drains, squeezed around the building and above the water-table, created an invisible holding tank. The 6" pipe and new rip-rap on the bank limited erosion and avoided archaeology on NPS land.

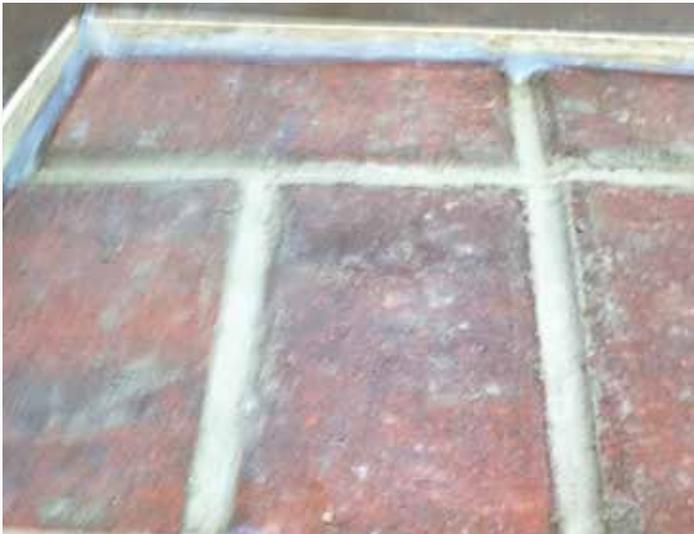
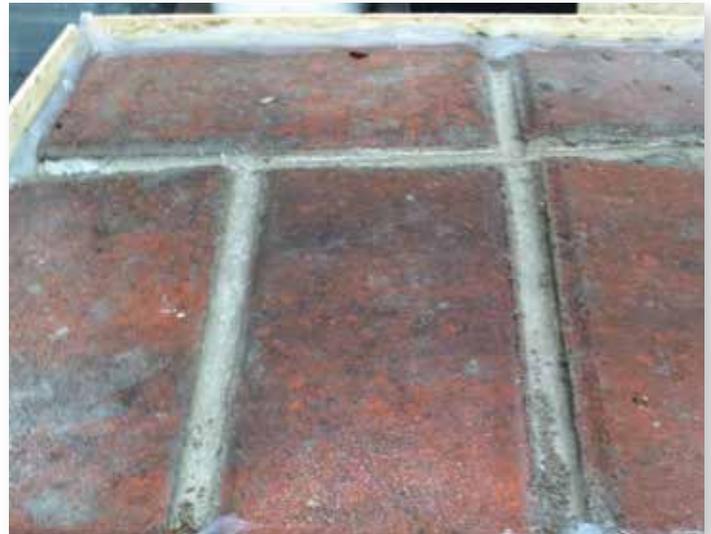
BEFORE AND AFTER PHOTOS OF NATURAL CEMENT MORTAR 1:1 WITH AMENDMENT AFTER 50 FREEZE-THAW CYCLES.

Early freeze thaw failures of air-entrained Type O portland cement-lime masonry mortar on projecting elements at the East Block on Parliament Hill in Ottawa led to initiation of a testing program aimed at evaluating a potential amendment for improving freeze-thaw resistance. Early freeze-thaw failures of several natural cement pavement mortars led to a second study, examining a variety of historic mortars in pavement joints, including natural cement, natural hydraulic lime and portland cement-lime mortars.

The presentation reviews the testing programs and methods, the materials evaluated, the results of testing, and the mortar amendments determined to be most effective at improving freeze-thaw resistance while maintaining high moisture vapor permeability. Saturation coefficient reduction was determined to be the most effective strategy for improving performance in salt-scaling resistance, as determined in ASTM C672 testing. ●

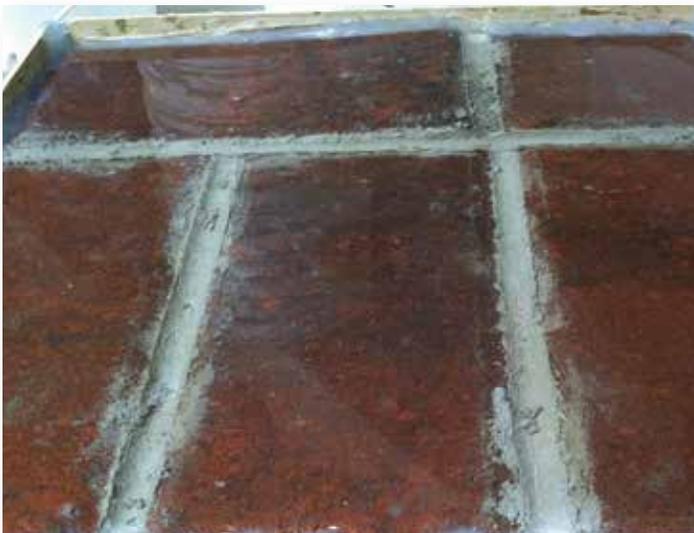
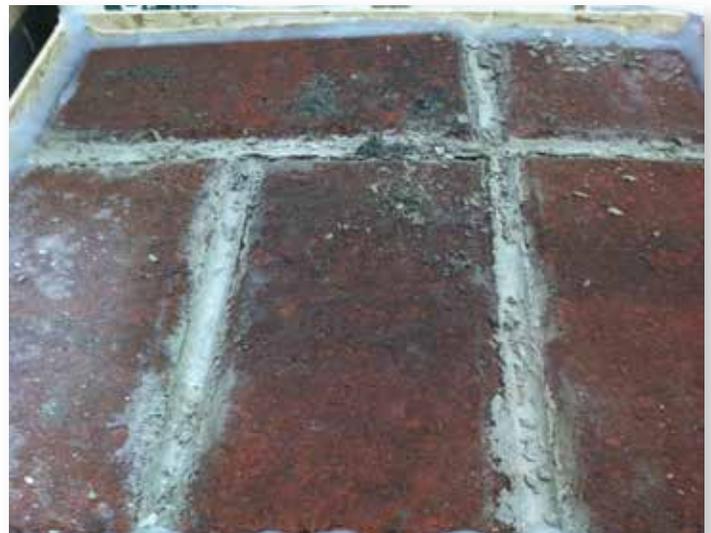
BEFORE AND AFTER PHOTOS OF NATURAL CEMENT MORTAR 1:1 WITHOUT AMENDMENT AFTER 3 FREEZE-THAW CYCLES.

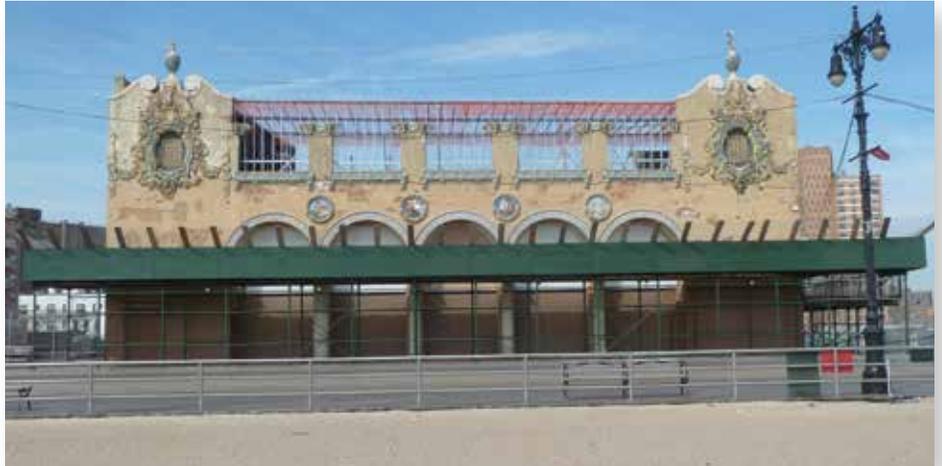
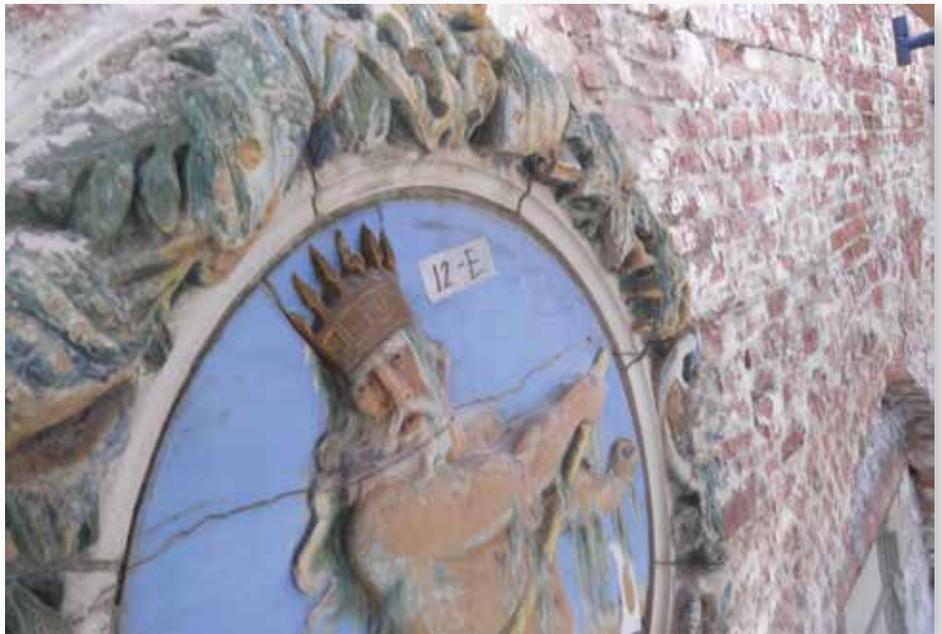
The degradation has affected the unique terra cotta elements, delicate stone (marble), stucco, and brick. The building is being restored with the intent of matching original details while taking into consideration the buildings' adaptive reuse into a performance space and restaurant called Seaside Park and Community Arts Center.

Designed by Hiron and Dennison in a "resort style with Spanish Revival influence" and built in 1923, this massive "terra cotta palace by the sea" became a New York City Landmark in 2002. The building was designed to look as if it was "washed up by the sea" and is adorned with a variety of flamboyant, colorful terra cotta aquatic ornamentation including Poseidon, sailing ships, sea horses, squid, crabs, and seaweed.

After the restaurant closed, the building had a variety of uses, the last being a candy factory. The city currently owns the structure. The building had obligatory maintenance until approximately 10 to 15 years ago. Since that time, the maintenance lapsed allowing the building to deteriorate exponentially. Other deterioration mechanisms have also contributed to the current state of this 92-year-old building →
